LIMITED ROOF SURVEY

PHOEBE PARK ASSOCIATION

RE: Limited Roof Survey of Phoebe Park Association

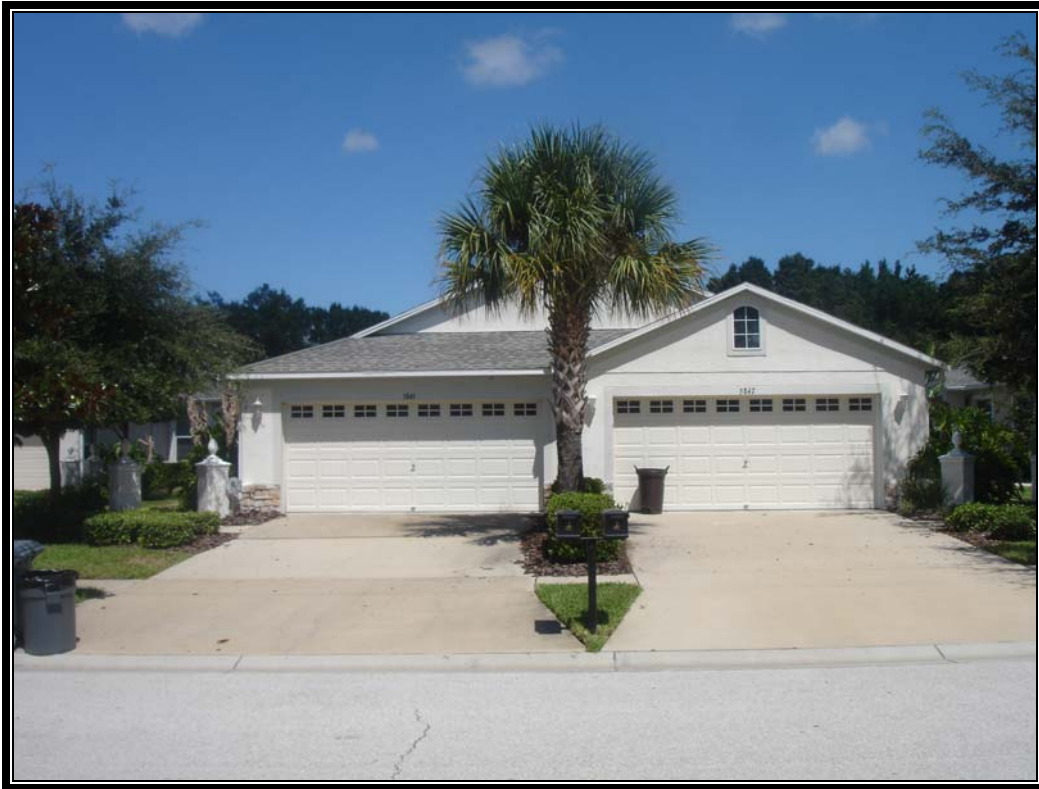
PHOTO #1: FRONT VIEW - TYPICAL

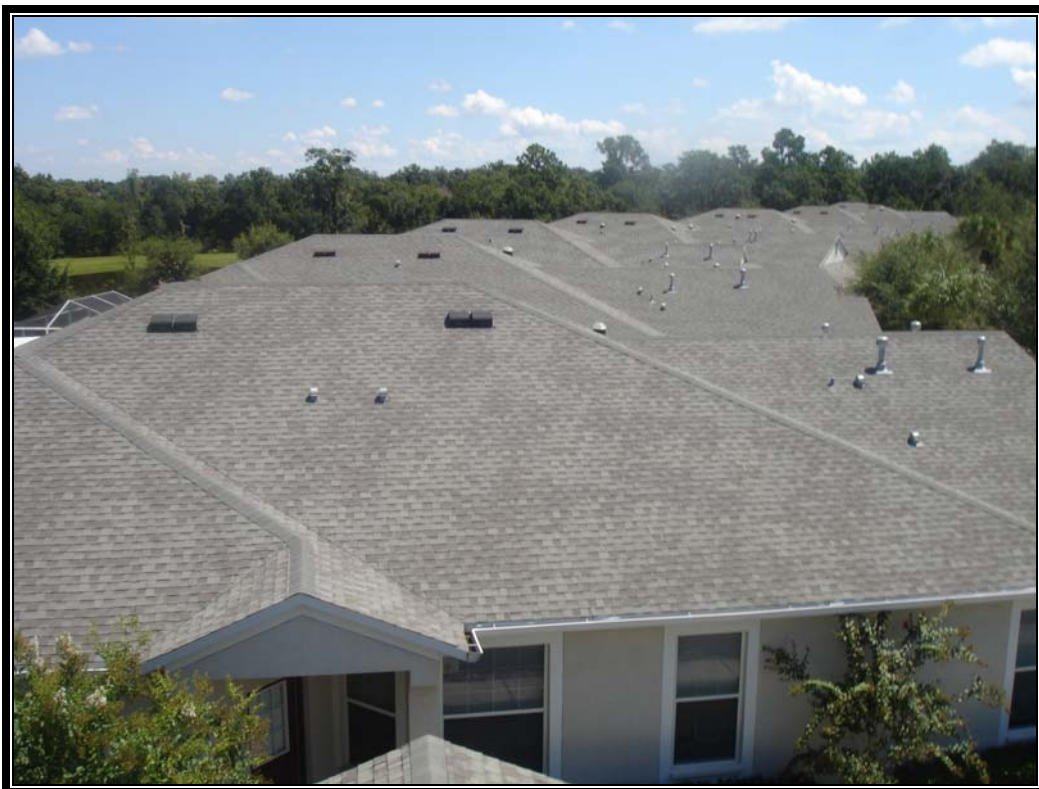
PHOTO #2: ROOF OVERVIEW - TYPICAL

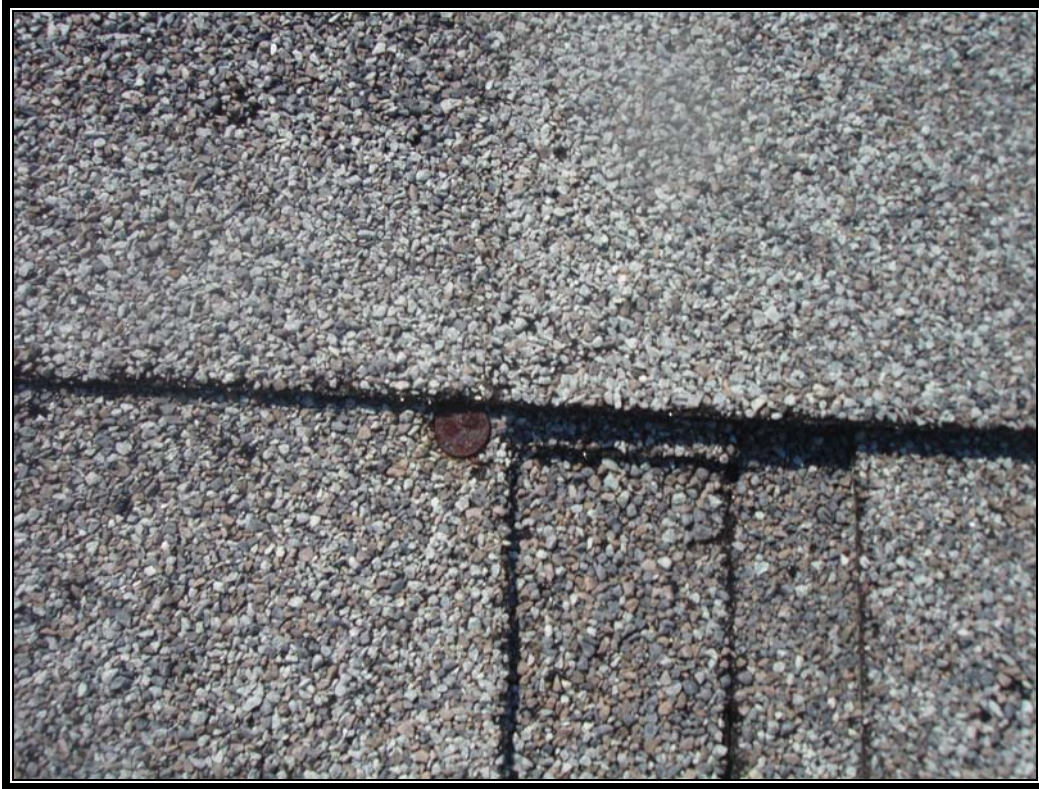
PHOTO #3: EXPOSED FASTENER – TYPICAL

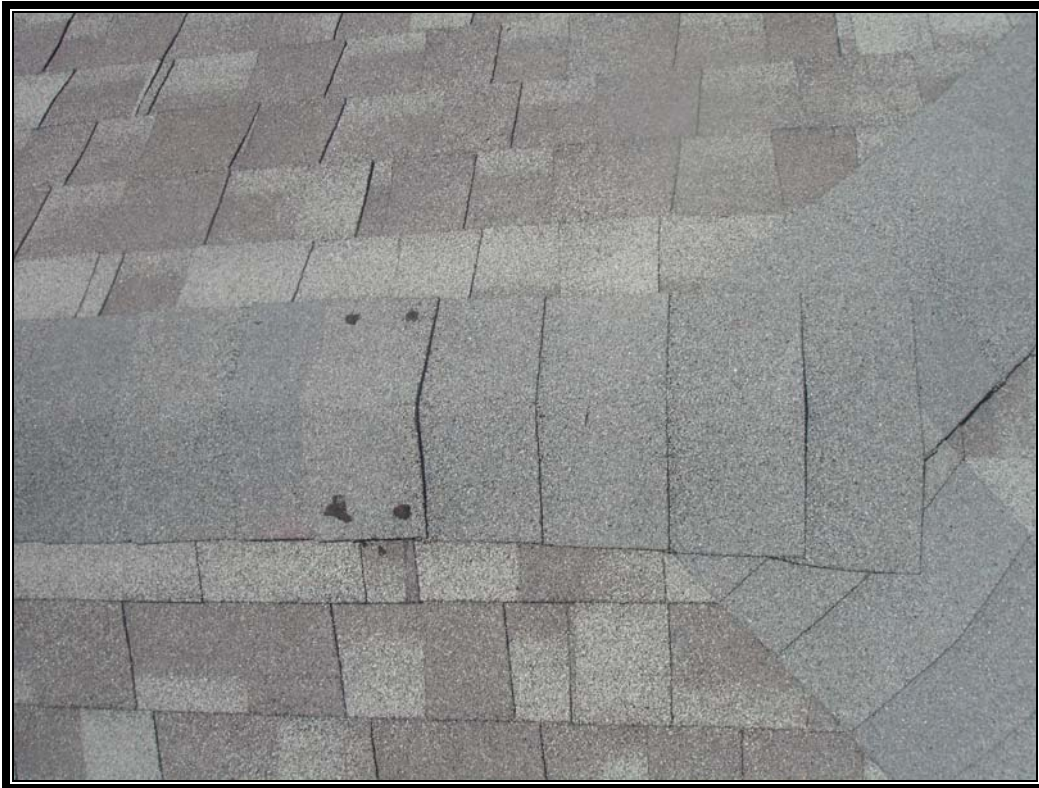
PHOTO #4: EXPOSED FASTENER - TYPICAL

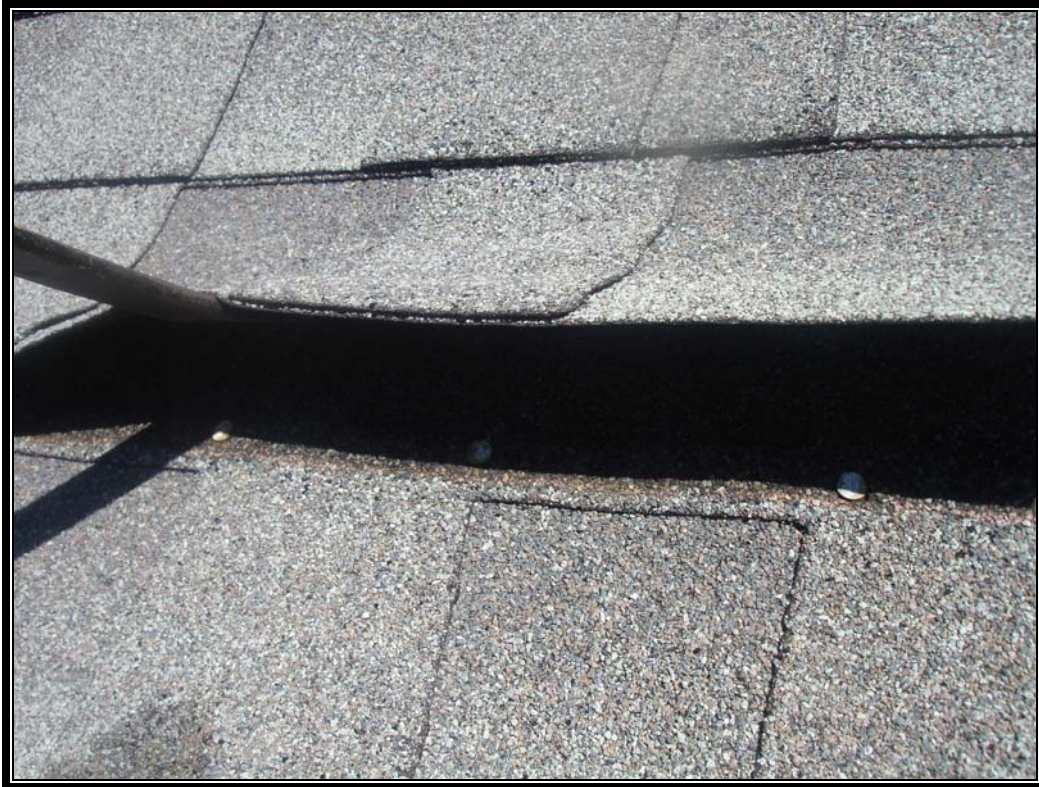
PHOTO #5: PROPER FASTENING PATTERN - TYPICAL

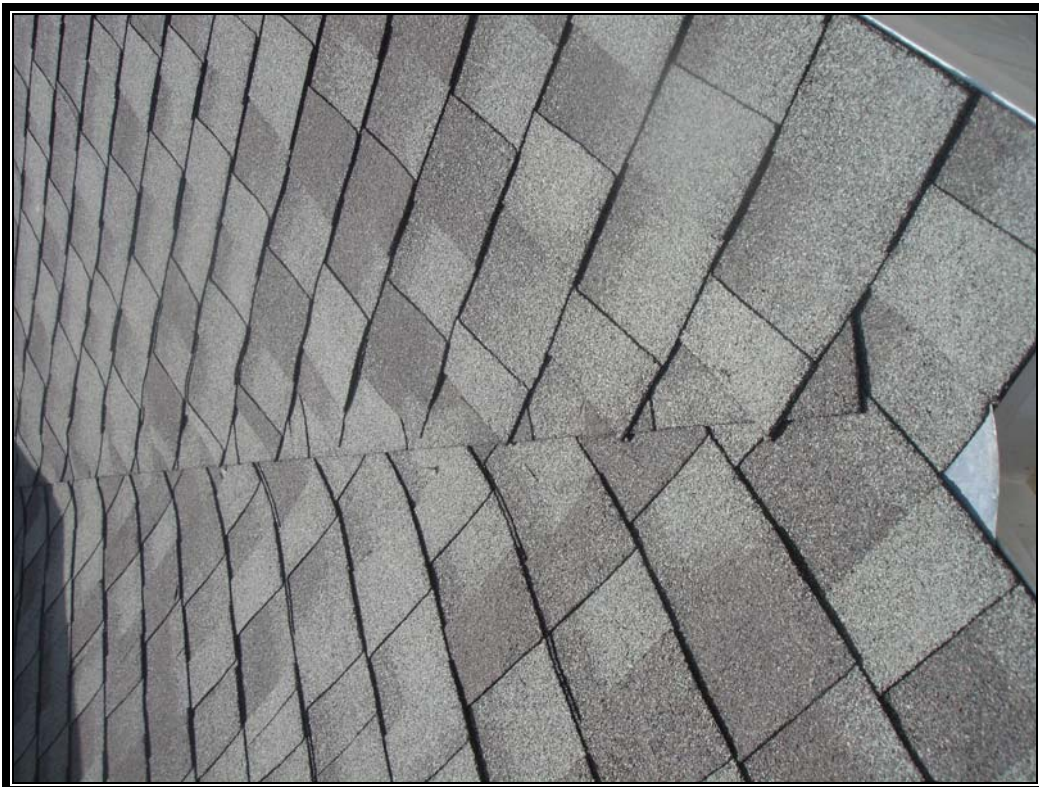
PHOTO #6: VALLEY DETAIL – TYPICAL
